Fire Risk Assessment

Hazelwood School

Date of Risk Assessment: 12th February 2024

Unique reference: FH146671707728400

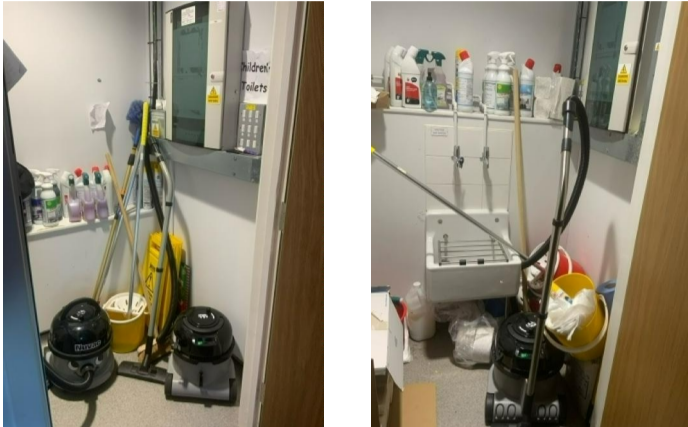
Do combustible materials appear to be separated from ignition sources?

There should be better management of the separation of combustible materials from potential ignition sources in all cleaner's cupboards in the Bailey building.

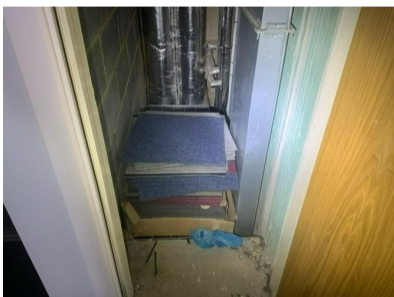
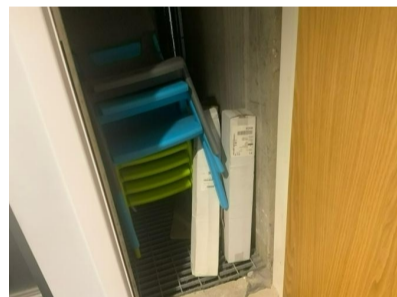
Has the unnecessary accumulation of combustible materials or waste been avoided?

There are areas where combustible materials are stored in an inappropriate place, the ground floor and lower ground risers of Bailey Building were not conceived as a storage area and provide a hazard due to fire load.

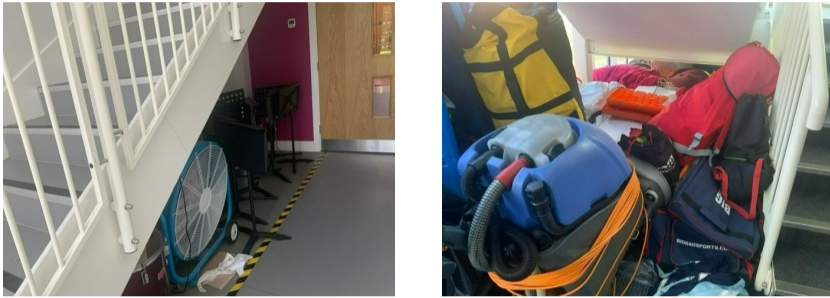
Has the unnecessary accumulation of combustible materials or waste been avoided?

The fire loading (readily combustible materials) should be removed from under the rear stairwell in the Bailey Building and rear Sports Hall stairwell and areas kept clear at all times.

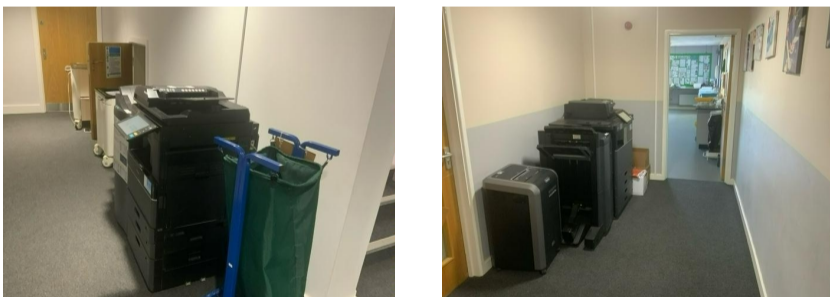
Is the design of the means of escape considered adequate?

The photocopiers and iPad charging units which are a potential ignition source should be relocated off the escape route corridor in the Bailey Building and Willow science area.

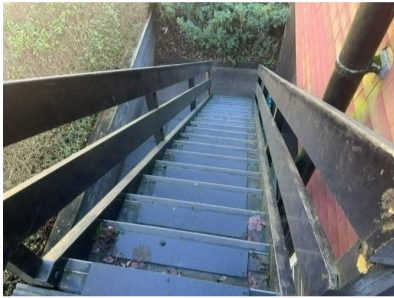
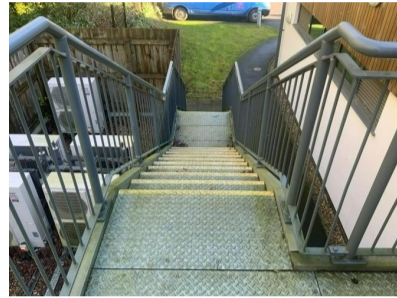
External escape stairs appeared to be in a good state of repair, however, there was no evidence to show that these have been inspected in the last 5 years.

Are any external escape stairs in a good state of repair and inspected in line with BS8210 - 2020?

External escape stairs should be inspected every 5 years in line with BS 8210 - 2010 British Standard Guide to Building Maintenance Management.

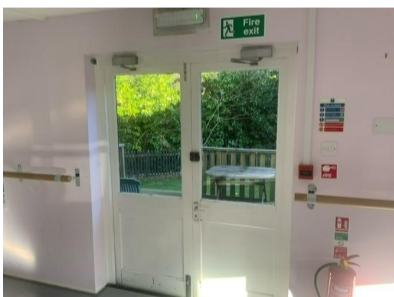
Do all fire exits open easily, immediately and in the direction of escape where necessary?

Repair/replace final exit doors from the dance studio so they open easily in an emergency.

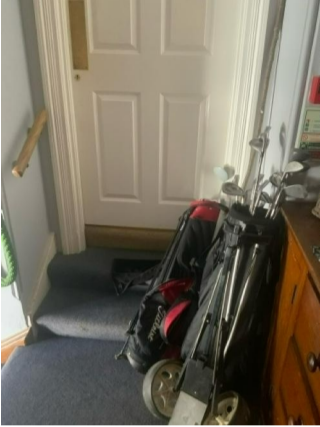
Are escape routes unobstructed?

The escape routes from the first floor of the main building to the headteacher's flat, the escape route rear of the Sports Hall, Acorns corridor dance studio to the flat entrance and the top floor Acorns by flat door are not free of unnecessary materials and obstructions. The escape routes should be kept clear at all times to maintain the exits.

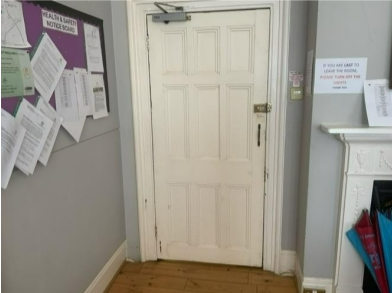
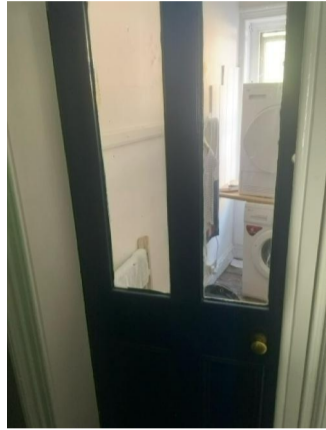
Are fire doors installed and, if so, what type of fire doors are installed?

The following doors should be replaced with FD30 (s) fire door Staff room door. Laundry room door.

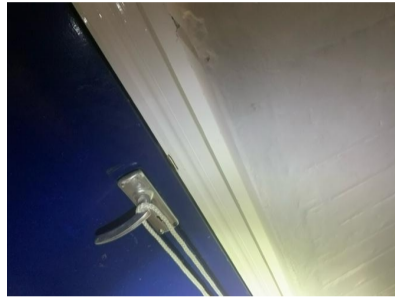
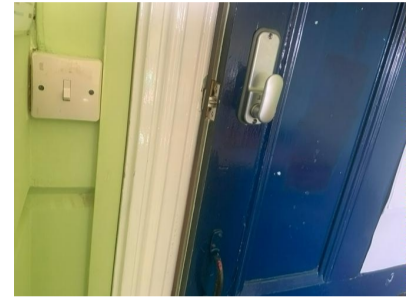
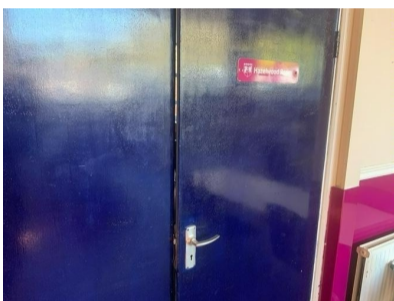
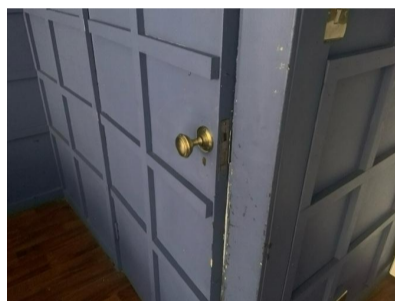
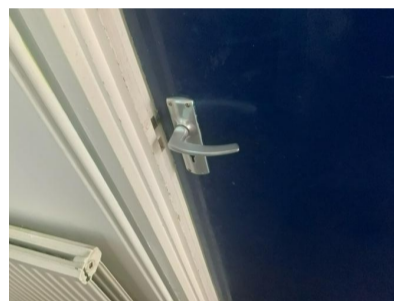
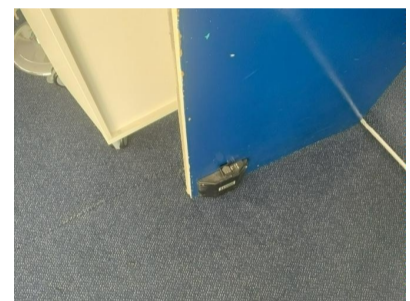
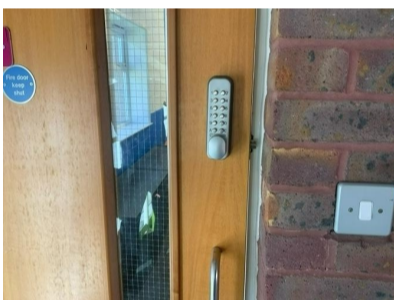
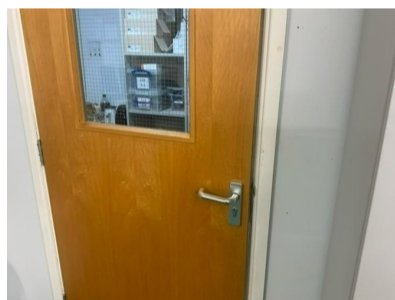
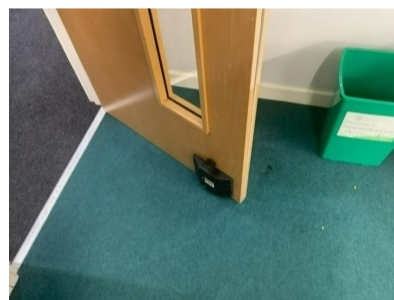
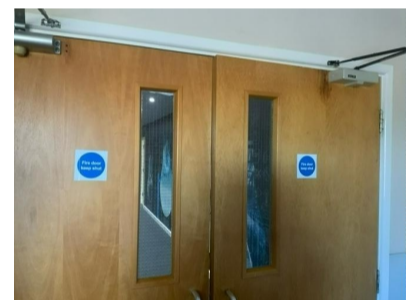
Do fire doors close correctly into their rebates and latches?

The following doors should be eased and adjusted to ensure they close correctly into their latch: Parcel room door main building, Corridor door maintenance area, Lamda room 1, Lamda room 2, Hazelwood room in dining hall x 2, Catering office dining hall, Graphics studio dining hall, Rear Cardio suite door Sports hall, Outer Door to the server room, Door to ICT manager office, Corridor door in willow to stairs to side fire exit.

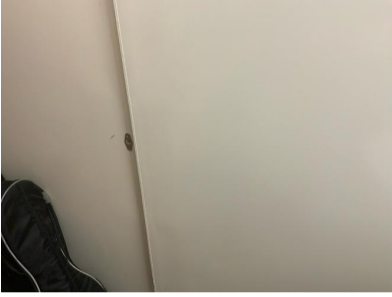
Are fire doors in a reasonable state of repair?

Fit a lock to the electrical cupboard door in the music store in the Bailey Building.

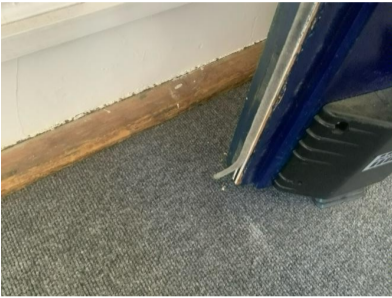
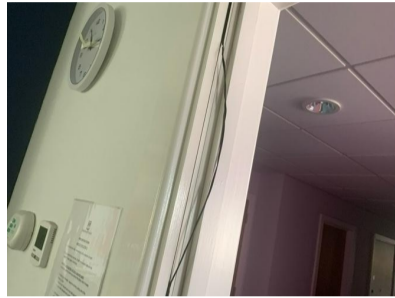
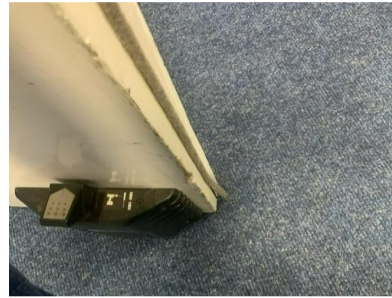
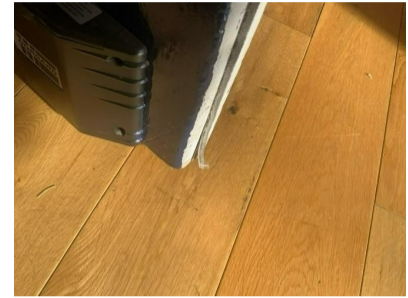
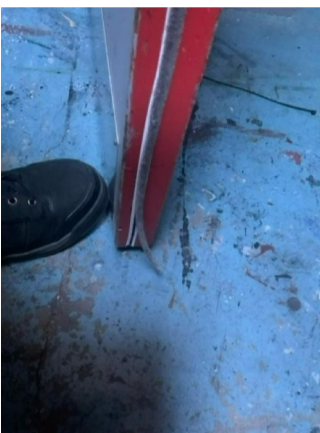
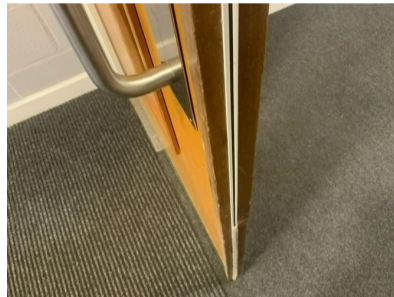
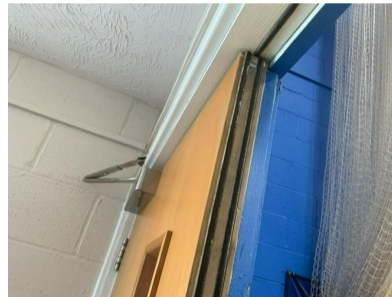
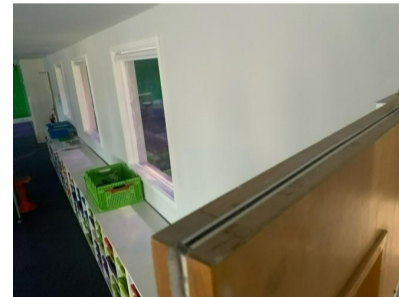
Are fire doors in a reasonable state of repair?

Replace damaged or missing intumescent strips and seal the following doors: R/s door main school, Music room main school, The old school hall main building, 3m Bailey building, Theatre props room in the theatre, Entrance corridor in Sports hall, Rear Sports hall door, The box top edge of the door.

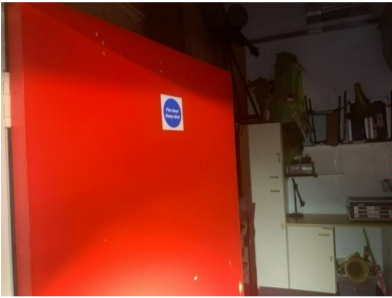
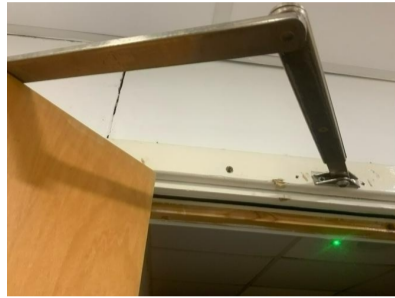
Are fire doors in a reasonable state of repair?

Install a self-closing device in the lightbox room in the theatre. Repair the damaged self-closer corridor door to the changing rooms in the Sports hall.

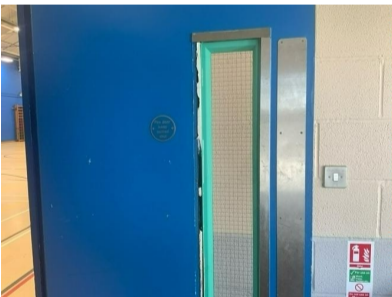
Are fire doors in a reasonable state of repair?

The following fire door should be repaired due to damage to the glazing: Rear Sports hall door beading around the vision panel.

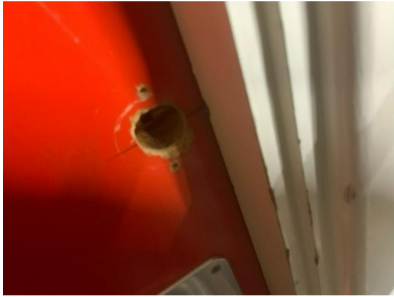
Are fire doors in a reasonable state of repair?

Repair the damaged fire door to the lightbox room in the theatre.

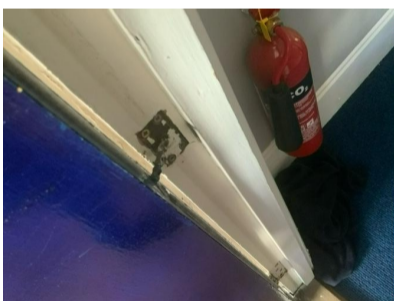
Are fire doors in a reasonable state of repair?

Replace the worn Perko closer to the MFL 1 door.

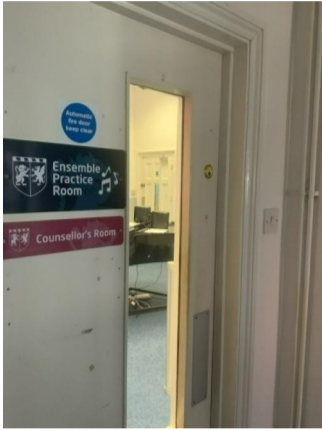
Are fire doors in a reasonable state of repair?

Remove the lock from the music room door and main building so the door can be used from both ways if required.

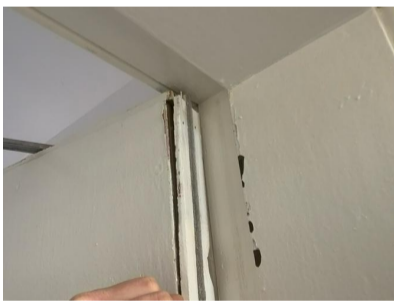
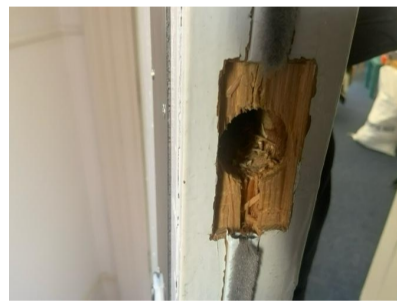
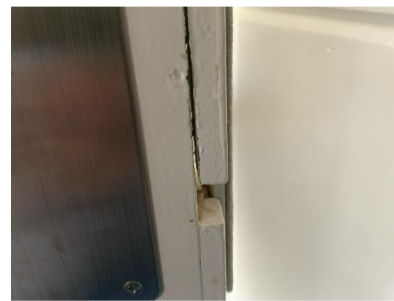
Are fire doors in a reasonable state of repair?

The following fire door should be repaired due to damage to the frame and lock: SMT1 door.

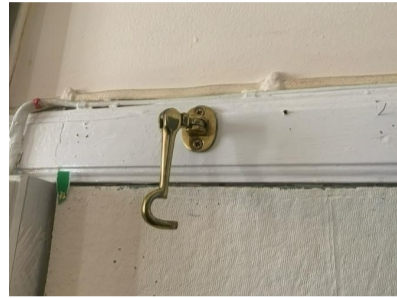
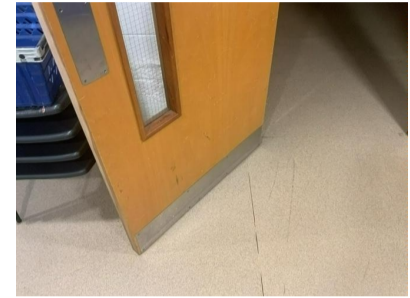
Where fire doors are wedged open, are automatic closers installed?

The following fire doors should not be wedged open. They should either be kept closed into the latch at all times or an automatic door closer installed: Parcel room door, MFL2 door, Outer doors at the foot of the stairs to the chapel in the theatre, Corridor to the changing rooms in the Sports hall.

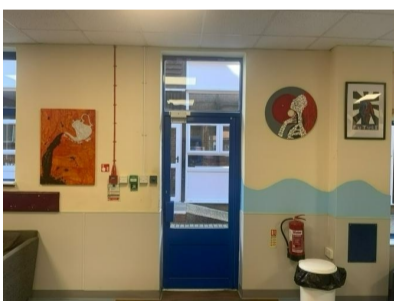
Is there a reasonable standard of directional fire safety signs?

Additional directional signs should be installed above the exit door from the locker room in the main building.

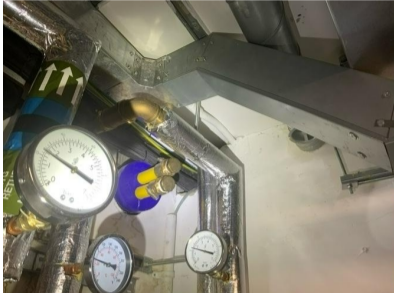
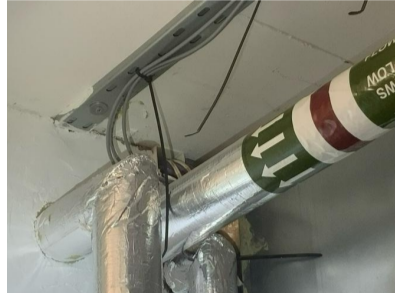
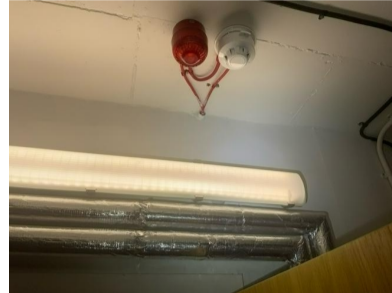
Are fire protected service risers, ducts and cupboards in a good state of repair and will they restrict the spread of fire and smoke?

Fire-stop the service penetration holes in the main boiler room of Bailey building.

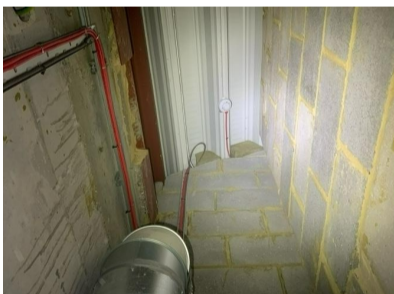
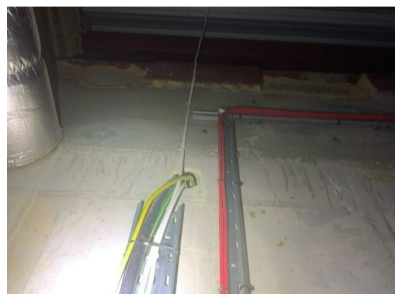
Are fire protected service risers, ducts and cupboards in a good state of repair and will they restrict the spread of fire and smoke?

Fire-stop the holes/gaps on top of the riser in the Bailey building on the first floor by the lift.

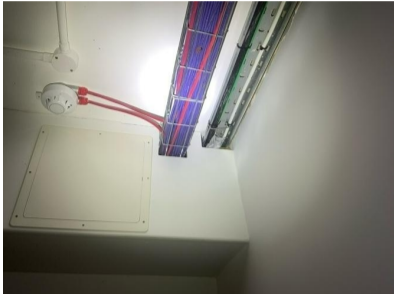
Are fire protected service risers, ducts and cupboards in a good state of repair and will they restrict the spread of fire and smoke?

Fire-stop the service penetration holes in the server room of the Bailey Building.

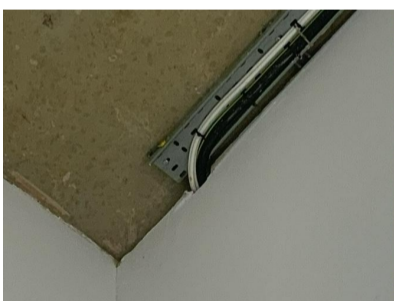
Are fire protected service risers, ducts and cupboards in a good state of repair and will they restrict the spread of fire and smoke?

Fire-stop the service penetration hole from the electrical cupboard in the music store room in the Bailey Building.

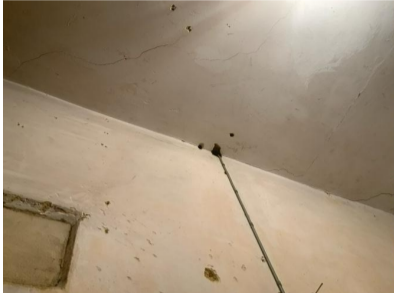
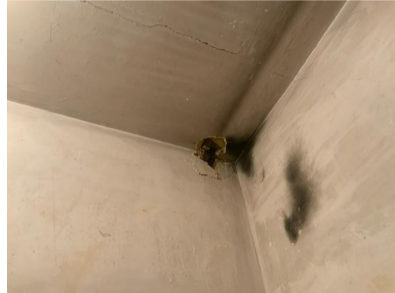
Are fire protected service risers, ducts and cupboards in a good state of repair and will they restrict the spread of fire and smoke?

Fire-stop holes in the cleaning cupboard in the main school by the staff room.

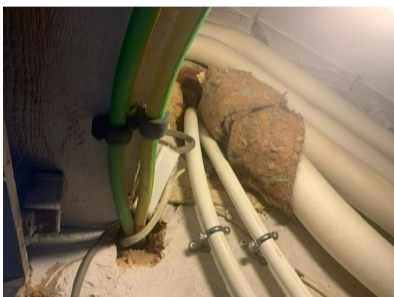
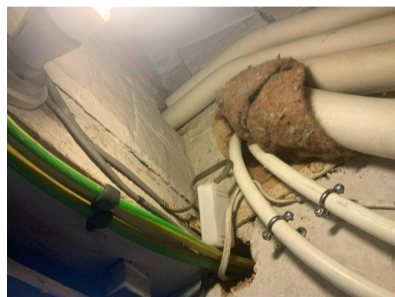
Are fire protected service risers, ducts and cupboards in a good state of repair and will they restrict the spread of fire and smoke?

Fire-stop the service penetration holes above the door in the basement.

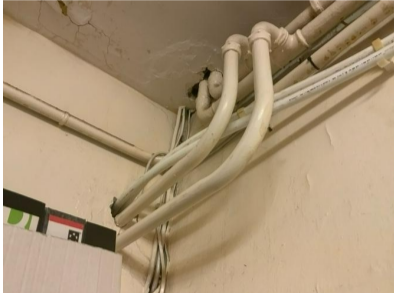
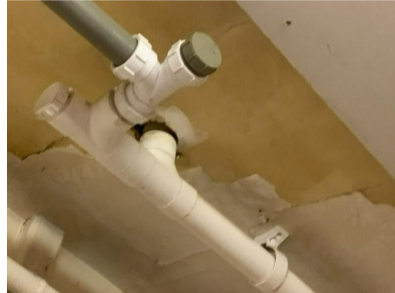
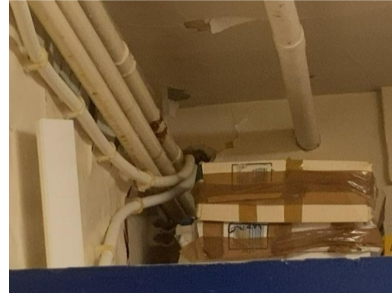
Are fire protected service risers, ducts and cupboards in a good state of repair and will they restrict the spread of fire and smoke?

Fire-stop the service penetration holes in the stationery cupboard in the main school.

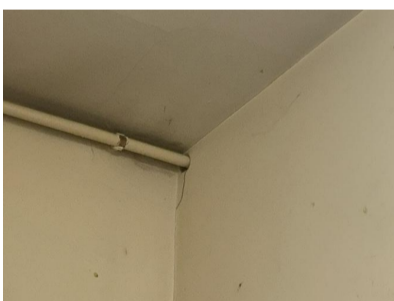
Are fire protected service risers, ducts and cupboards in a good state of repair and will they restrict the spread of fire and smoke?

Fire-stop the service penetration in the maintenance cupboard in the main school.

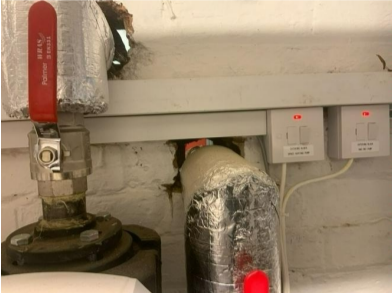
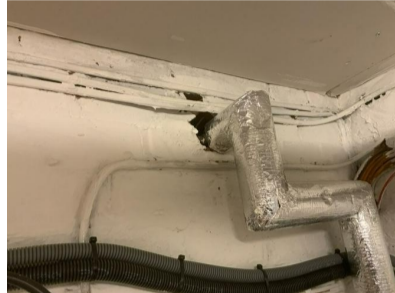
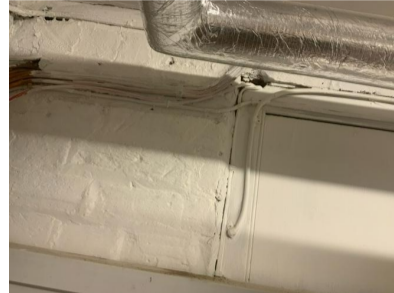
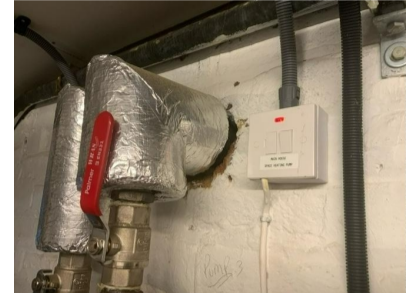
Are fire protected service risers, ducts and cupboards in a good state of repair and will they restrict the spread of fire and smoke?

Fire-stop the service penetration holes in the gas boiler room in the maintenance area in the main school.

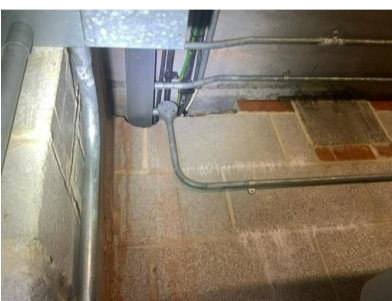
Are fire protected service risers, ducts and cupboards in a good state of repair and will they restrict the spread of fire and smoke?

Fire-stop holes in the boiler room in the changing rooms in the Sports hall.

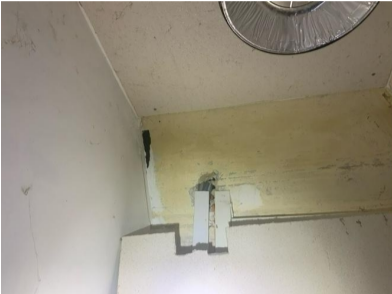
Are fire protected service risers, ducts and cupboards in a good state of repair and will they restrict the spread of fire and smoke?

Fire-stop holes in the ceiling of the electrical cupboard in the Acorns building.

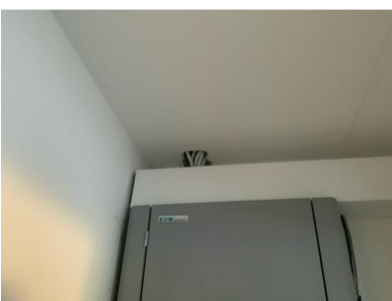
Are fire protected service risers, ducts and cupboards in a good state of repair and will they restrict the spread of fire and smoke?

Fire-stop the service penetration holes in the Naismith Pavilion.

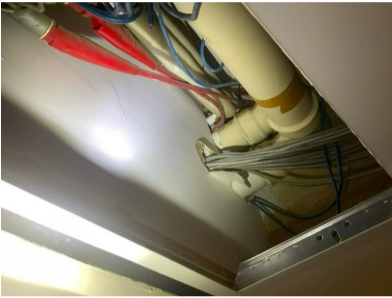
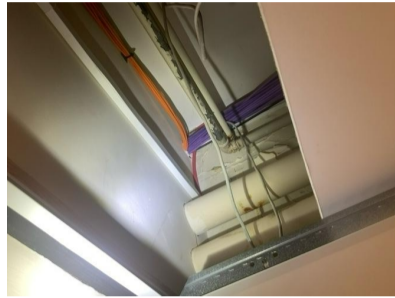
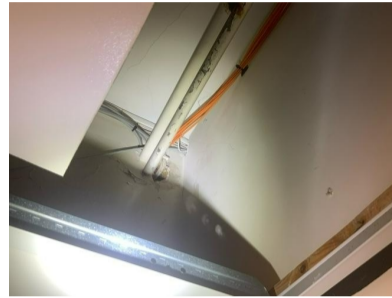
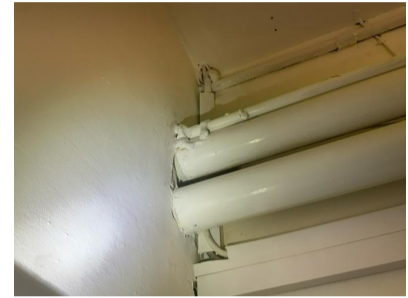
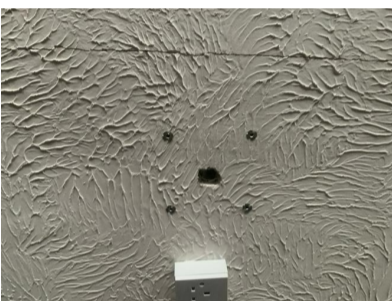
Is the fire-resisting construction which protects escape routes in good condition?

Fire-stop the service penetrations above corridor door finance to staff room and finance to stairwell. Fire-stop the service penetrations above corridor doors from 1. finance to staff room, 2. finance to stairwell, 3. finance to maintenance. Repair the hole in the ceiling of the IT room in Willow.
