Fire Risk Assessment

Hazelwood School

Date of Risk Assessment: 12th February 2024

Unique reference: FH146671707728400

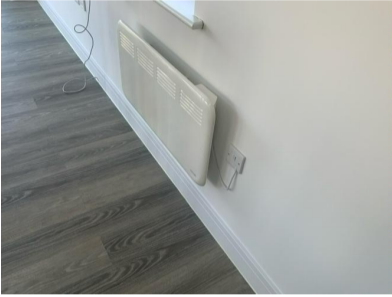
Where wall-mounted electrical heaters are in use, are they subject to their own maintenance regime?

Wall-mounted electrical heaters are not covered by either PAT or a fixed wiring system and should be subject to additional maintenance in line with the manufacturer's requirements.

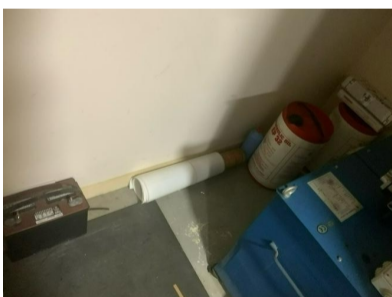
Do combustible materials appear to be separated from ignition sources?

Remove combustible materials from the lift motor room in Willow.

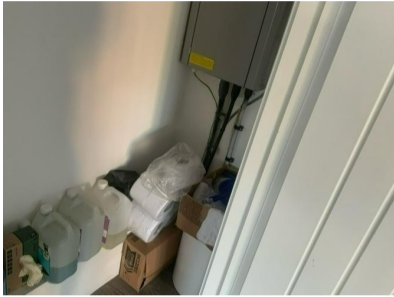
Do combustible materials appear to be separated from ignition sources?

There should be better management of the separation of combustible materials from potential ignition sources in the Naismith Pavilion electrical cupboard.

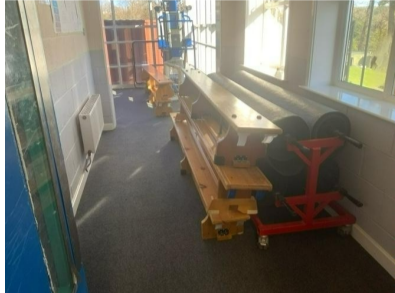
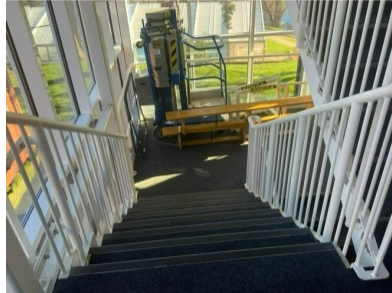
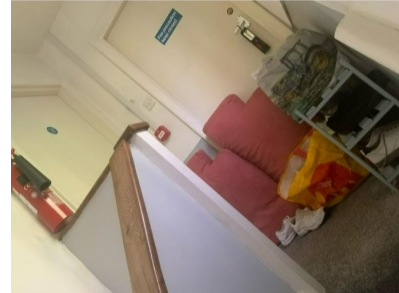
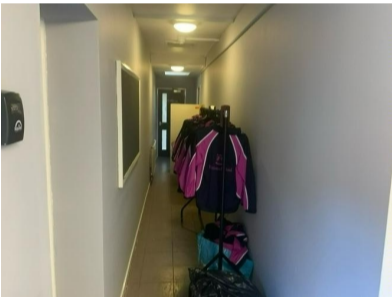
Are escape routes unobstructed?

The escape routes from the first floor of the main building to the headteacher's flat, the escape route rear of the Sports Hall, Acorns corridor dance studio to the flat entrance and the top floor Acorns by flat door are not free of unnecessary materials and obstructions. The escape routes should be kept clear at all times to maintain the exits.

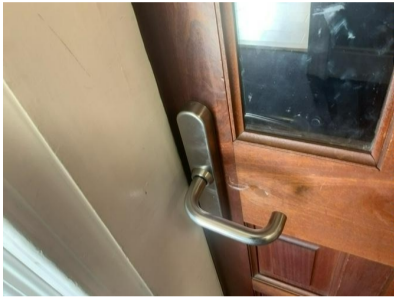
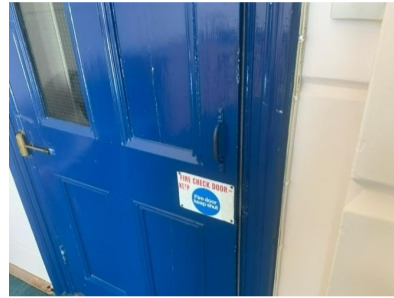
Do fire doors close correctly into their rebates and latches?

The following doors should be eased and adjusted to ensure they close correctly into their latch: Parcel room door main building, Corridor door maintenance area, Lamda room 1, Lamda room 2, Hazelwood room in dining hall x 2, Catering office dining hall, Graphics studio dining hall, Rear Cardio suite door Sports hall, Outer Door to the server room, Door to ICT manager office, Corridor door in willow to stairs to side fire exit.

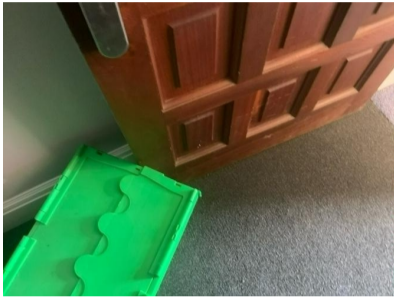
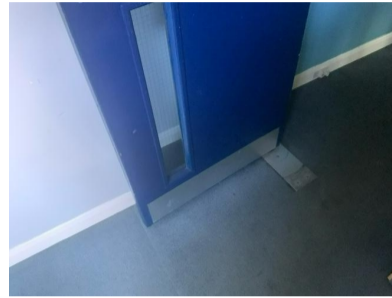
Where fire doors are wedged open, are automatic closers installed?

The following fire doors should not be wedged open. They should either be kept closed into the latch at all times or an automatic door closer installed: Parcel room door, MFL2 door, Outer doors at the foot of the stairs to the chapel in the theatre, Corridor to the changing rooms in the Sports hall.
